CASE STUDY

Biotifx® FOG Reduces Grease Cap, Sludge and Odors; Improving Lagoon Performance

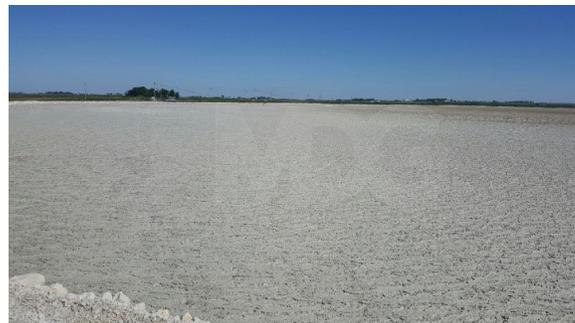
Image 1: Lagoon before treatment

Prior to product application, the FOG cap covered 100% of the lagoon and was six inches thick on average (Image 1). This was typical coverage and thickness of this lagoon in previous years. After 3 weeks of treatment, the FOG/protein cap was reduced to 60% coverage and was only two inches thick (Image 2). In addition, sludge build-up on the bottom of the lagoon and effluent nitrogen were significantly reduced after treatment (Table 1). The reduction in nitrogen was likely the result of FOG cap removal allowing for better oxygen transfer into the lagoon.

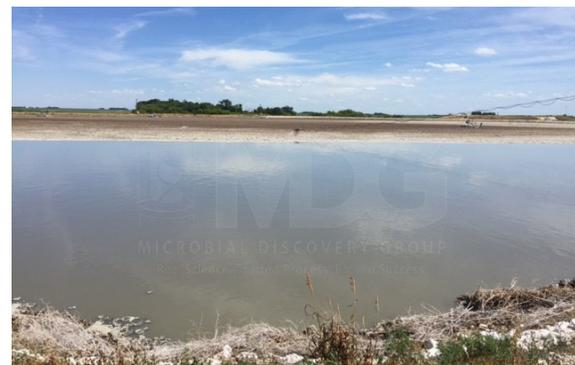
Image 2: Three weeks after treatment
