Biotifx® FOG Reduces Grease Cap, Sludge and Odors; Improving Lagoon Performance

A mid-western food processing facility with a large wastewater lagoon was seeing significant fat, oil and grease (FOG) and sludge build up resulting in poor treatment during summer months, and low capacity year round. After three weeks of treatment with Biotifx® FOG, there was a significant reduction in FOG and sludge build up and an improvement in overall lagoon performance.

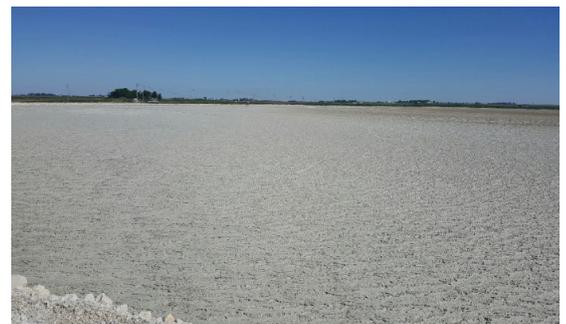
Image 1: Lagoon before treatment

Prior to product application, the FOG cap covered 100% of the lagoon and was six inches thick on average (Image 1). This was typical coverage and thickness of this lagoon in previous years. After 3 weeks of treatment, the FOG/protein cap was reduced to 60% coverage and was only two inches thick (Image 2). In addition, sludge build-up on the bottom of the lagoon and effluent nitrogen were significantly reduced after treatment (Table 1). The reduction in nitrogen was likely the result of FOG cap removal allowing for better oxygen transfer into the lagoon.

MEASURED VARIABLES	BEFORE TREATMENT	3 WEEKS AFTER TREATMENT
FOG cap % surface coverage	100%	60%
FOG cap thickness (inches)	6	2
Sludge on lagoon bottom (inches)	24	6
Total volume of FOG cap and sludge in lagoon	32,400 Cubic Yards (6,543,958 Gallons)	7,800 Cubic Yards (1,575,397 Gallons)
Effluent nitrogen (mg/L)	614	526
Gallons dischargeable based on nitrogen	16 million	18 million
Odor Rank (1 None - 10 Worst)	8	2
