Biotifx® FOG Reduces Grease Cap, Sludge and Odors; Improving Lagoon Performance

SUMMARY

A mid-western food processing facility with a large wastewater lagoon was seeing significant fat, oil and grease (FOG) and sludge build up resulting in poor treatment during summer months, and low capacity year round. After three weeks of treatment with Biotifx® FOG, there was a significant reduction in FOG and sludge build up and an improvement in overall lagoon performance.

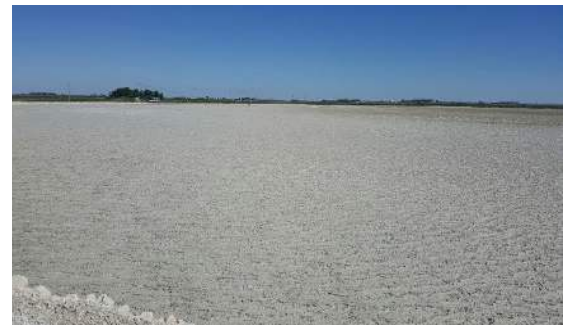
Image 1: Lagoon before treatment

Prior to product application, the FOG cap covered 100% of the lagoon and was six inches thick on average (Image 1). This was typical coverage and thickness of this lagoon in previous years. After 3 weeks of treatment, the FOG/protein cap was reduced to 60% coverage and was only two inches thick (Image 2). In addition, sludge build-up on the bottom of the lagoon and effluent nitrogen were significantly reduced after treatment (Table 1). The reduction in nitrogen was likely the result of FOG cap removal allowing for better oxygen transfer into the lagoon.

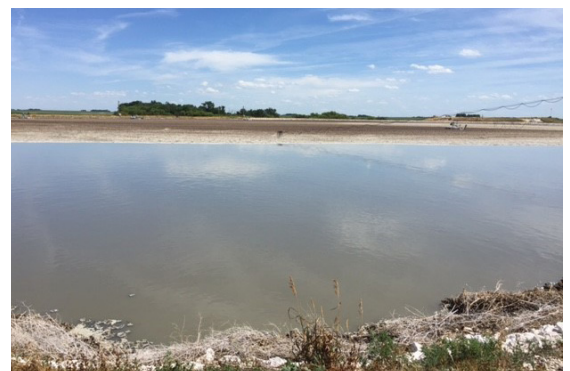
Image 2: Three weeks after treatment
